Prominent fibula

With Your® Liner

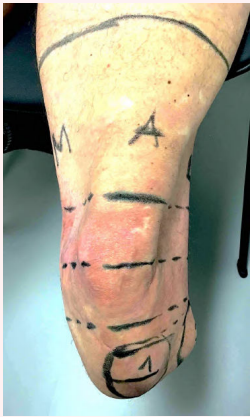
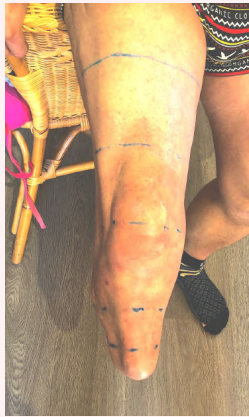
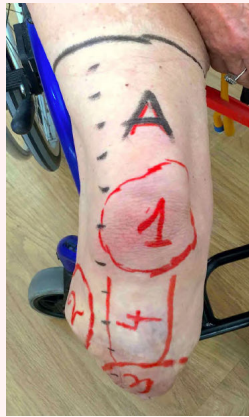
The fibula protrudes laterally. This area causes pain if exposed to pressure. Skin in this area can be prone to recurrent injuries.

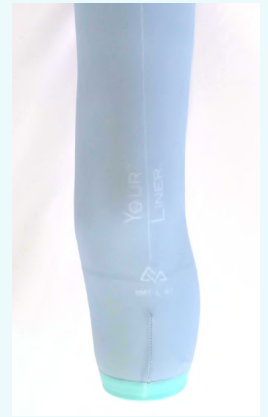
Your® Liner

As it's made from a 3D scan, Your® Liner's inner shape can match the protruding fibula shape, thus eliminating the risk of the liner being over-stretched and applying extra-compression on the fibula.

The possibility of locally applying adequate cushioning allows to apply adequate elastomer thickness to limit the risk of pressure peaks appearing on the fibula. The rest of the liner can present a thin profile to avoid the risks of having a heavier liner, additional pistoning and lowered proprioception.
